**AFTER THE GREAT FLOOD**

**REIMAGINING PHEASANT BRANCH CREEK**

# Reimagining the Pheasant Branch creek corridor

Adapted from 'Reimagining the Unimaginable' by students from the UW-MADISON DEPARTMENT OF PLANNING AND LANDSCAPE ARCHITECTURE, and the CARDNO STUDY

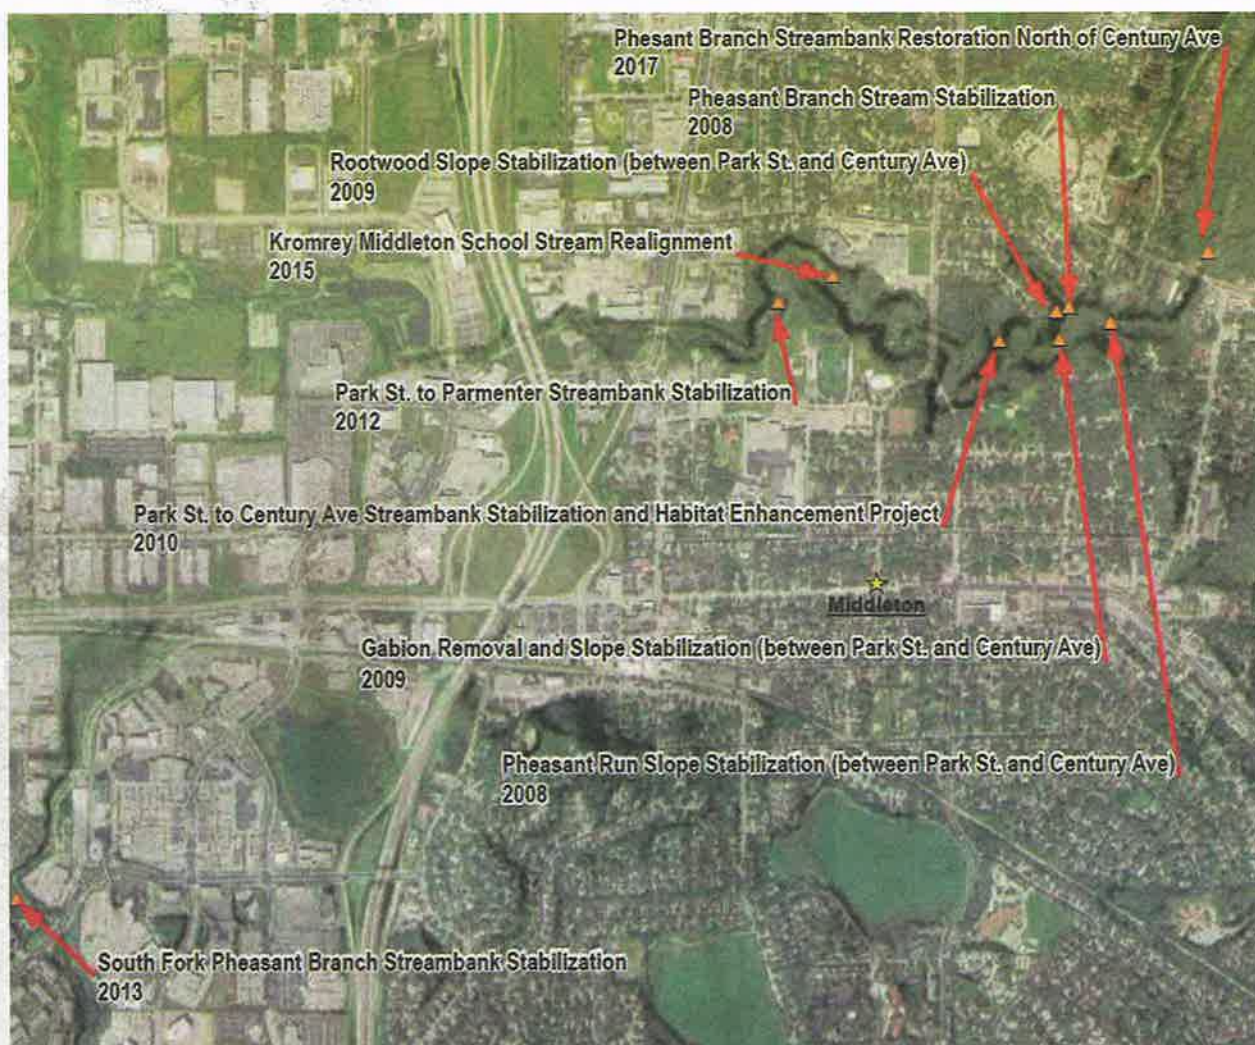
Channel erosion construction project locations within Pheasant Branch from 2007-2017.

Since 2007, the City of Middleton has been working with the Wisconsin Department of Natural Resources (WDNR) and the Federal Emergency Management Agency (FEMA) to repair severely eroded slopes within the Pheasant Branch corridor. (Table 1 on page 23, and map on page 25).

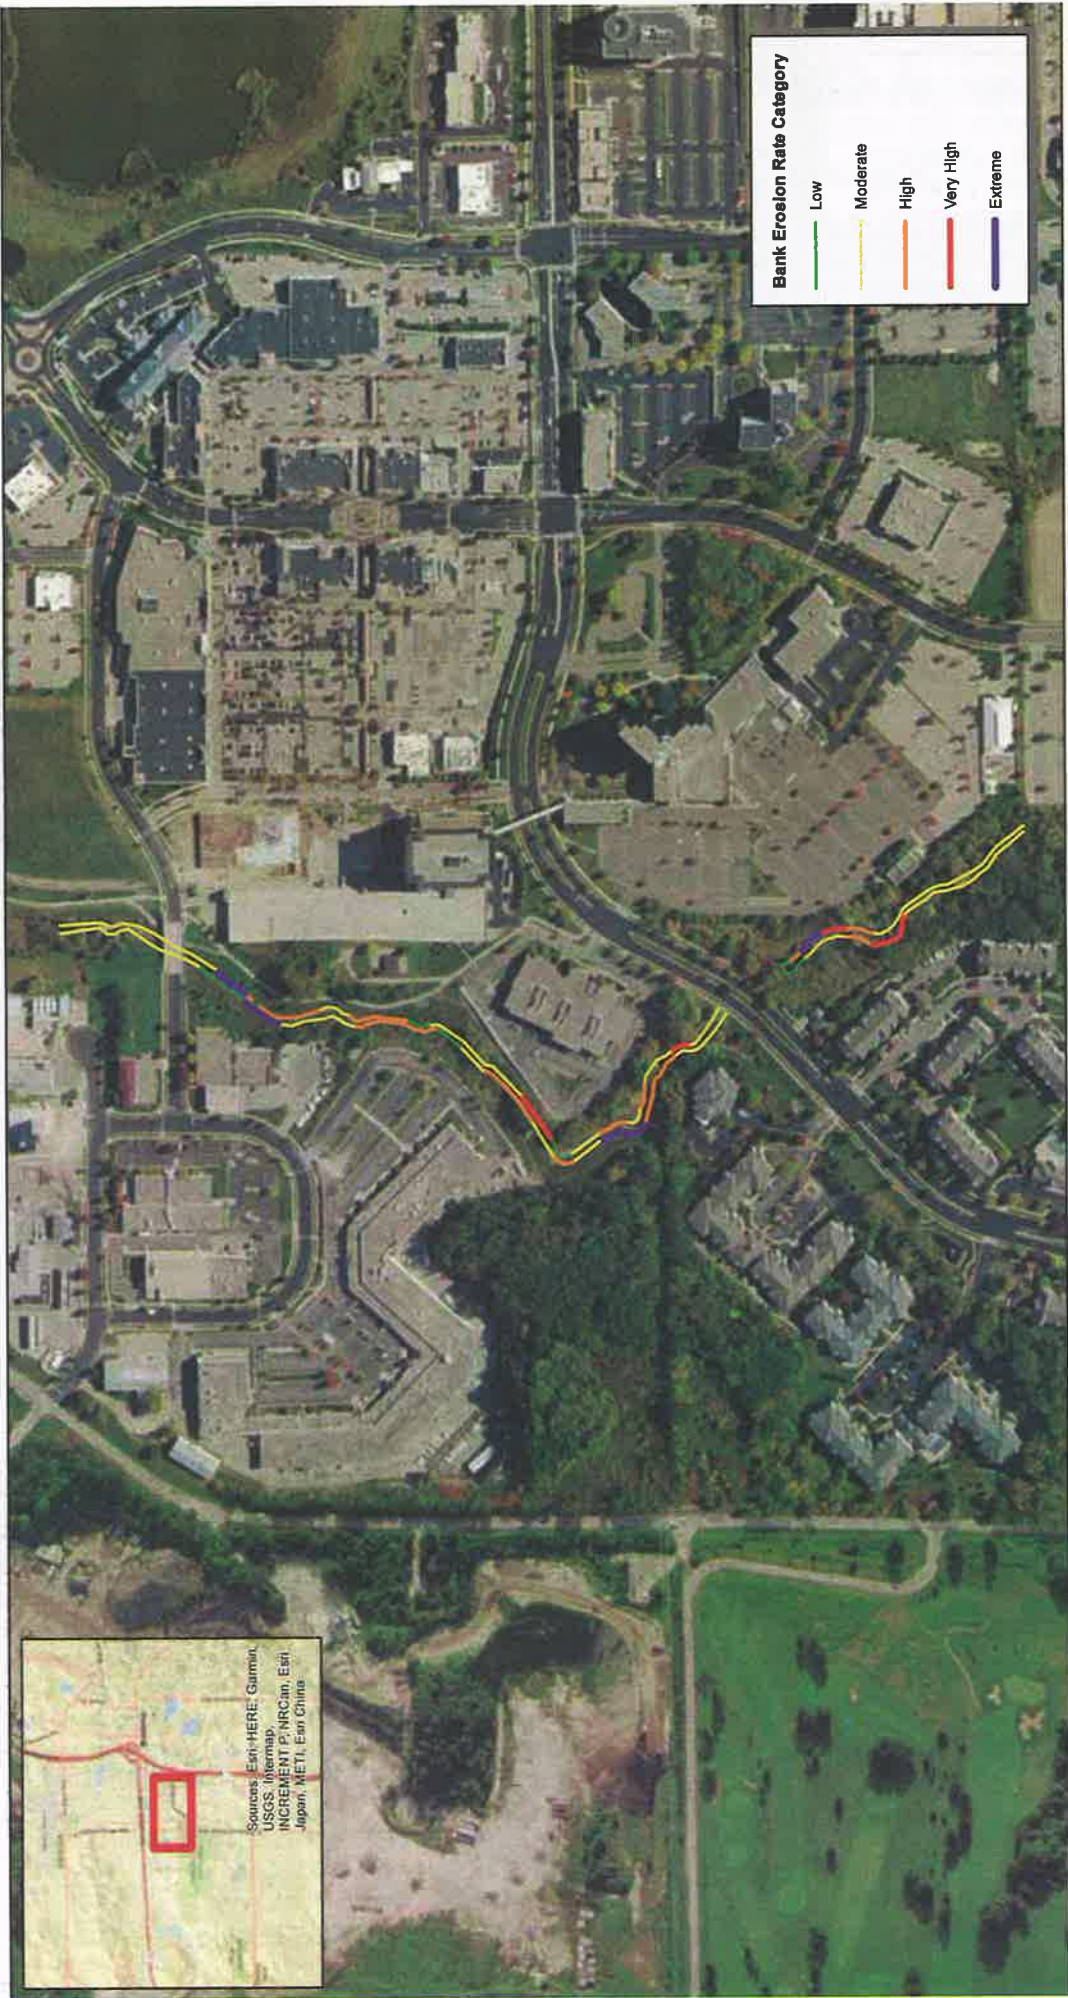
### Bank Erosion Survey Map - South Fork of Pheasant Branch

Pratt and Branch Bank Development  
Dane County, Wisconsin

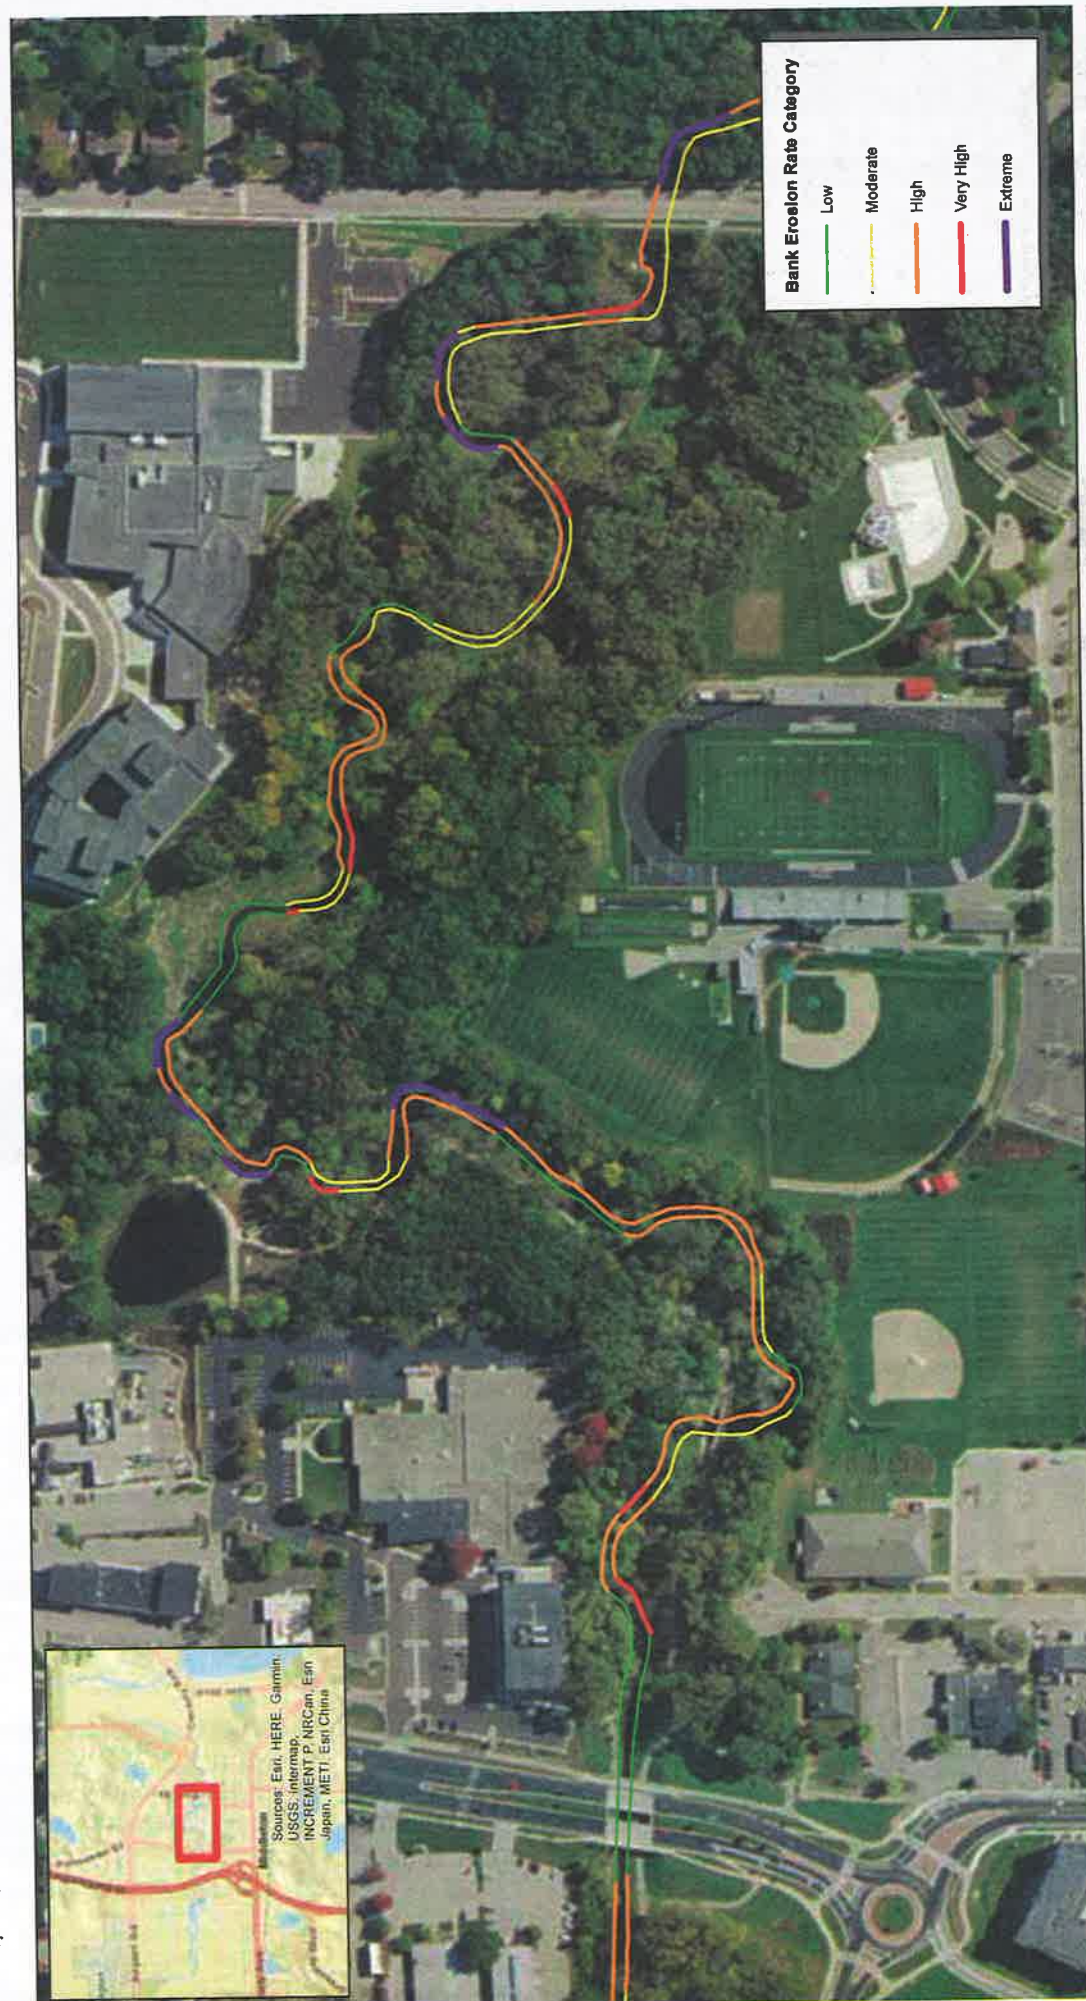
Bank Erosion Survey Map - Mainstem of Pheasant Branch from Parmenter to Park Street

Pheasant Branch Bank Assessment  
Dane County, Wisconsin
